Down-hole Camera of EPA Pavillion
Monitoring Well MW-02
Conducted on May 2, 2012
Prior to Redevelopment by the USGS

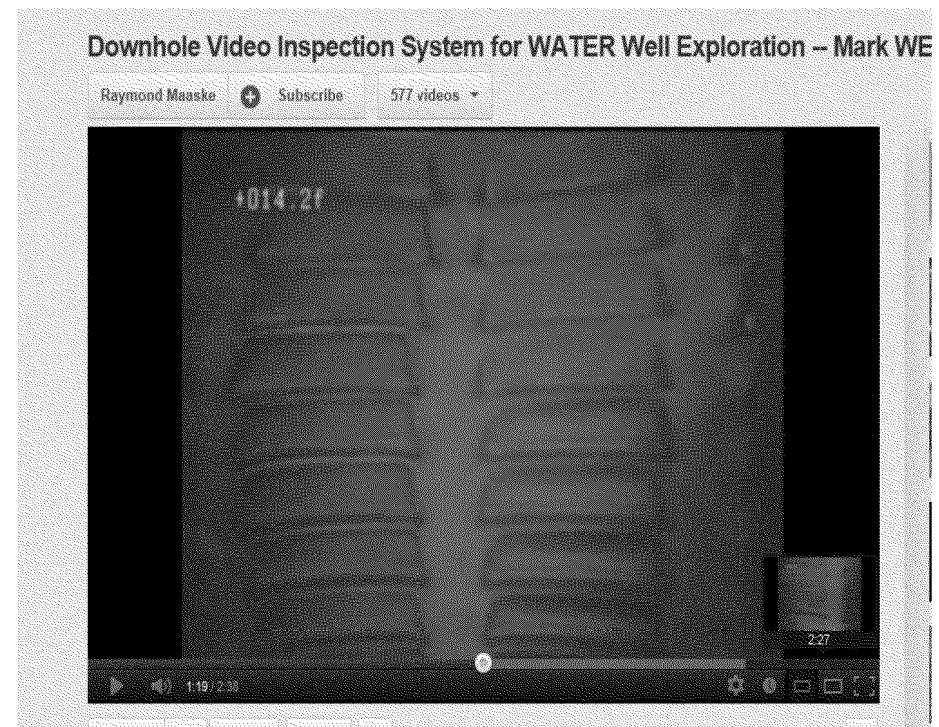
Example of Unobstructed Well Screen

Laval Underground Borehole Camera, R-CAM 1000
<http://www.youtube.com/watch?v=HY6Rjpn7qN0>
